Arboricultural Report

Tree Survey,
Arboricultural Impact Assessment &
Arboricultural Method Statement

**Lands at Palmerstown Retail Park
Kennelsfort Road Lower
Palmerstown
Dublin 20**

170914-PD-11e

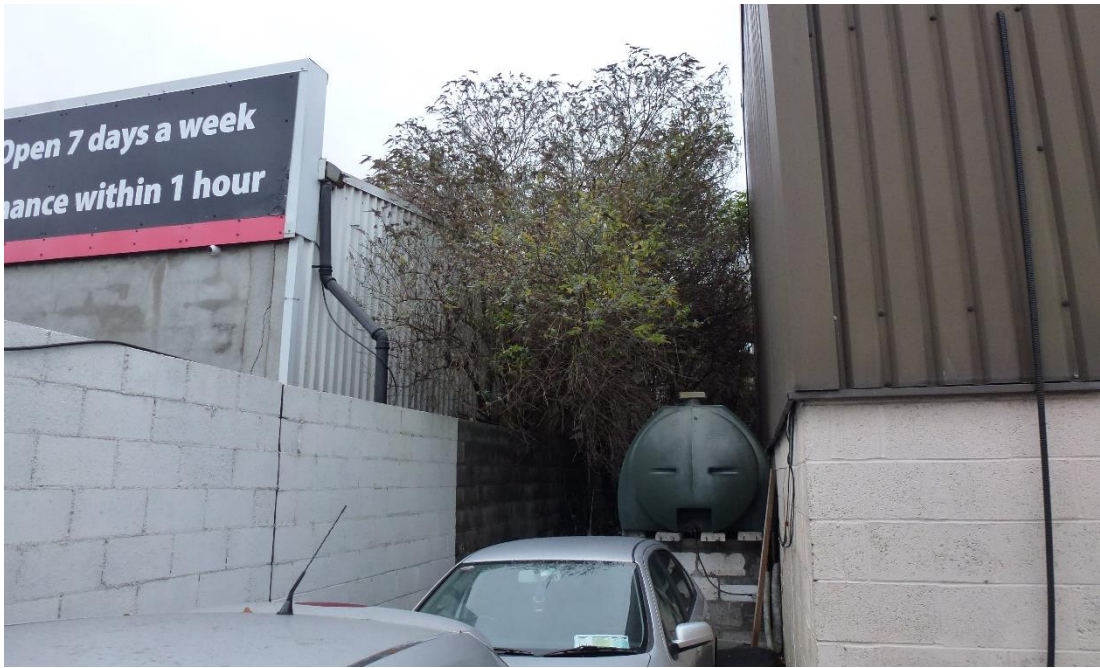
Photo 2 (CM / Nov '17): Typical view of self-seeded buddleia and elder shrubs within the site. Photo is of the southern section of S25.

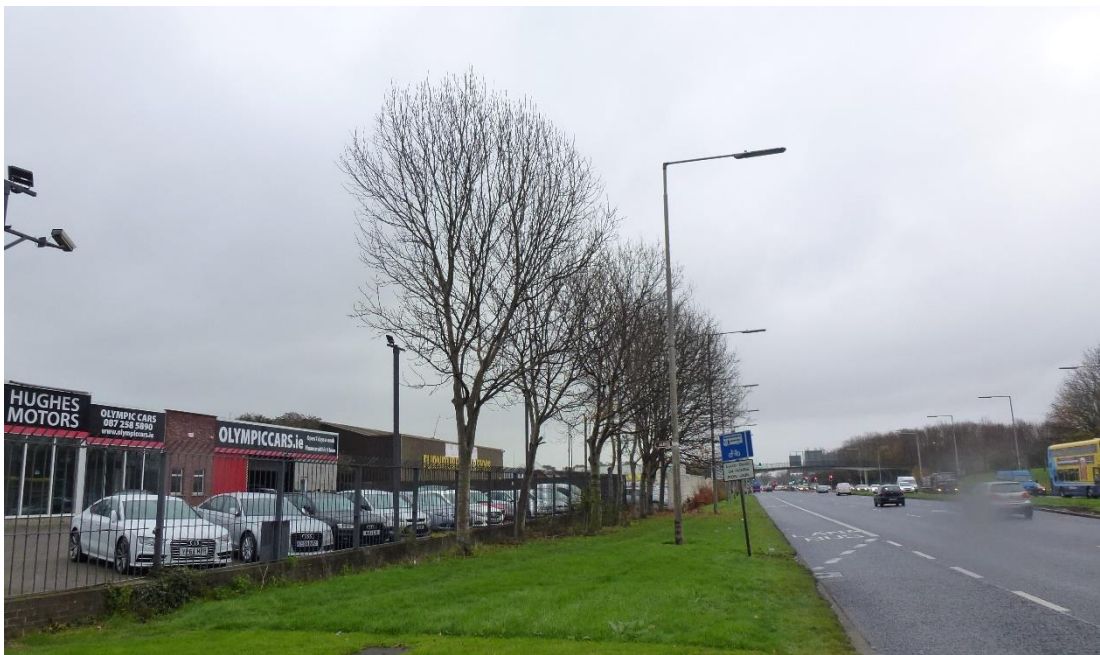
Photo 3 (CM / Nov '17): View of trees T7 to T19 located offsite and adjacent to the Chapelizod Bypass. These trees offer a visual and acoustic buffer between the site and the road.

- 5.24 **Daylight and sunlight levels** - The neighbouring trees along the southern boundary (T7 to T19) will cause some shading to the proposed residential properties. The design has taken this into consideration and included large windows to maximise daylight and sunlight levels.

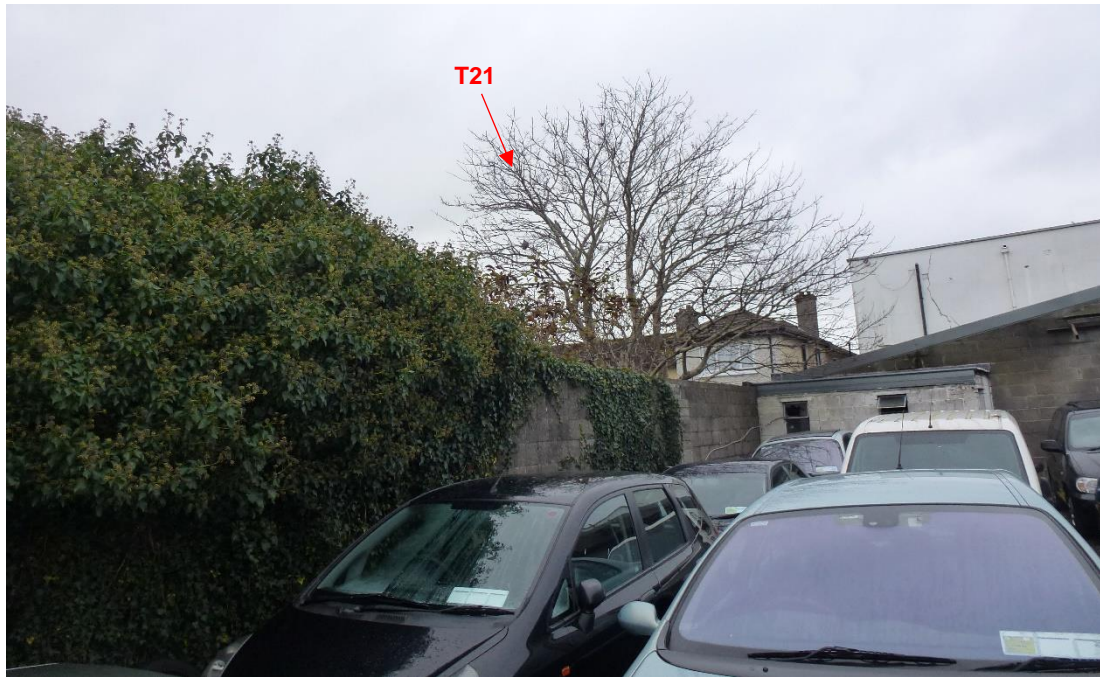
Photo 4 (CM / Nov '17): View of the neighbouring Norway maple tree T21 located along the north western boundary.

- 5.6 The proposal requires that neighbouring trees T21 and T23 are crown lifted within the site to provide clearance above the proposed road.
- 5.7 The proposed tree works recommended are considered to be minor and will not be detrimental to the health of the trees concerned or the character and appearance of the local area.

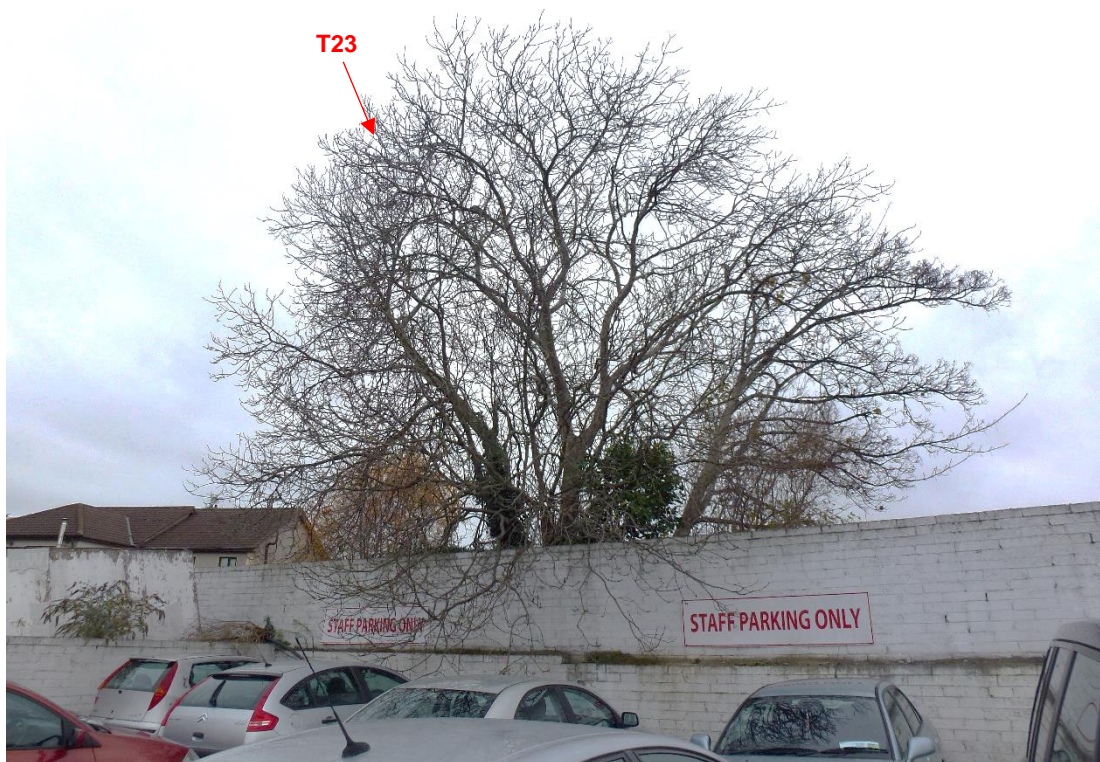
Photo 5 (CM / Nov '17): View of the neighbouring mature ash tree T23 located along the north western boundary.

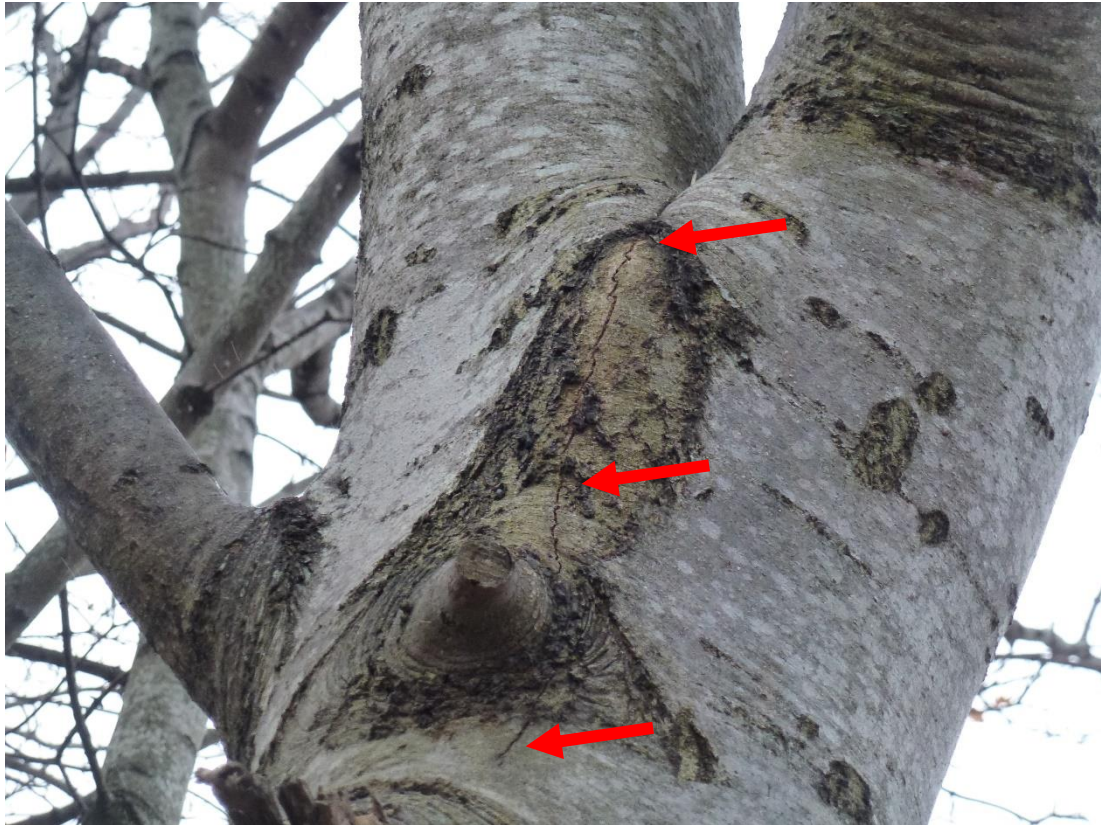
Photo 6 (CM / Nov '17): View of the cracked included union on the offsite ash tree T7. Red arrows highlight the location of the crack.

Tree T7	1 Fraxinus excelsior (Ash)	13.5	32	1		5.0		5.0		6.0		1.0	2.0		Early Mature	Structural condition Poor. Physiological condition Fair. Branch - Broken. Competition - Adjacent trees. Crown conflict - Structure / boundary / wire / tree. Fork - Cracked. Fork - Weak with included bark. Pruning wounds - Historic. Storm damage. Unbalanced crown - Minor. Crown clearance on site side is 4 metres. Tree is located offsite. Main included union is cracked. Notify tree owner of structural defect and high risk of failure. Small retaining wall to the north east. Level within site is slightly higher than around tree stem.	30/11/2017	46.3	3.8	0-10	U

- 5.2 It was noted during the survey that two neighbouring trees (T7 & T30) are in poor condition and as a result their removal has been recommended for arboricultural reasons. The main included union on the early mature ash tree (T7) has cracked. This has significantly increased the likelihood of failing occurring in the future, refer to Photo 6. The neighbouring whitebeam tree (T30) is dead and its structure will continue to deteriorate. Due to the location of both trees it is recommended that they are removed for health and safety purposes.
