Arboricultural Report

Tree Survey,
Arboricultural Impact Assessment &
Arboricultural Method Statement

**Lands at Palmerstown Retail Park
Kennelsfort Road Lower
Palmerstown
Dublin 20**

170914-PD-11e

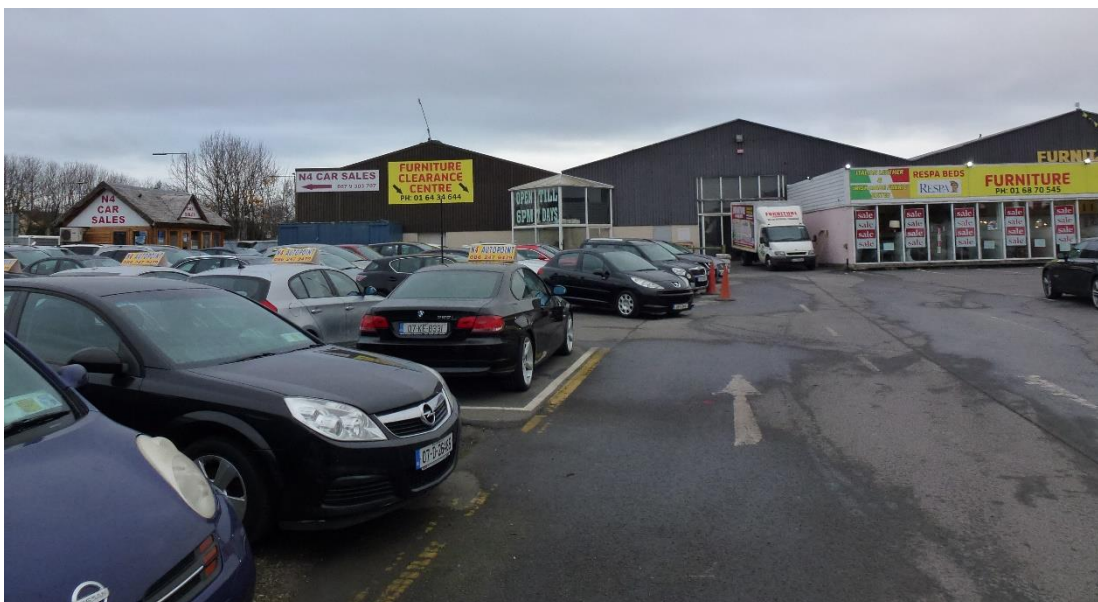
Photo 1 (CM / Nov '17): View of the commercial units within the site and the expansive area of tarmac used for car parking and sales.
